## dsPIC33EPXXXGS70X/80X Family Silicon Errata and Data Sheet Clarification

The dsPIC33EPXXXGS70X/80X family devices that you have received conform functionally to the current Device Data Sheet (DS70005258B), except for the anomalies described in this document.

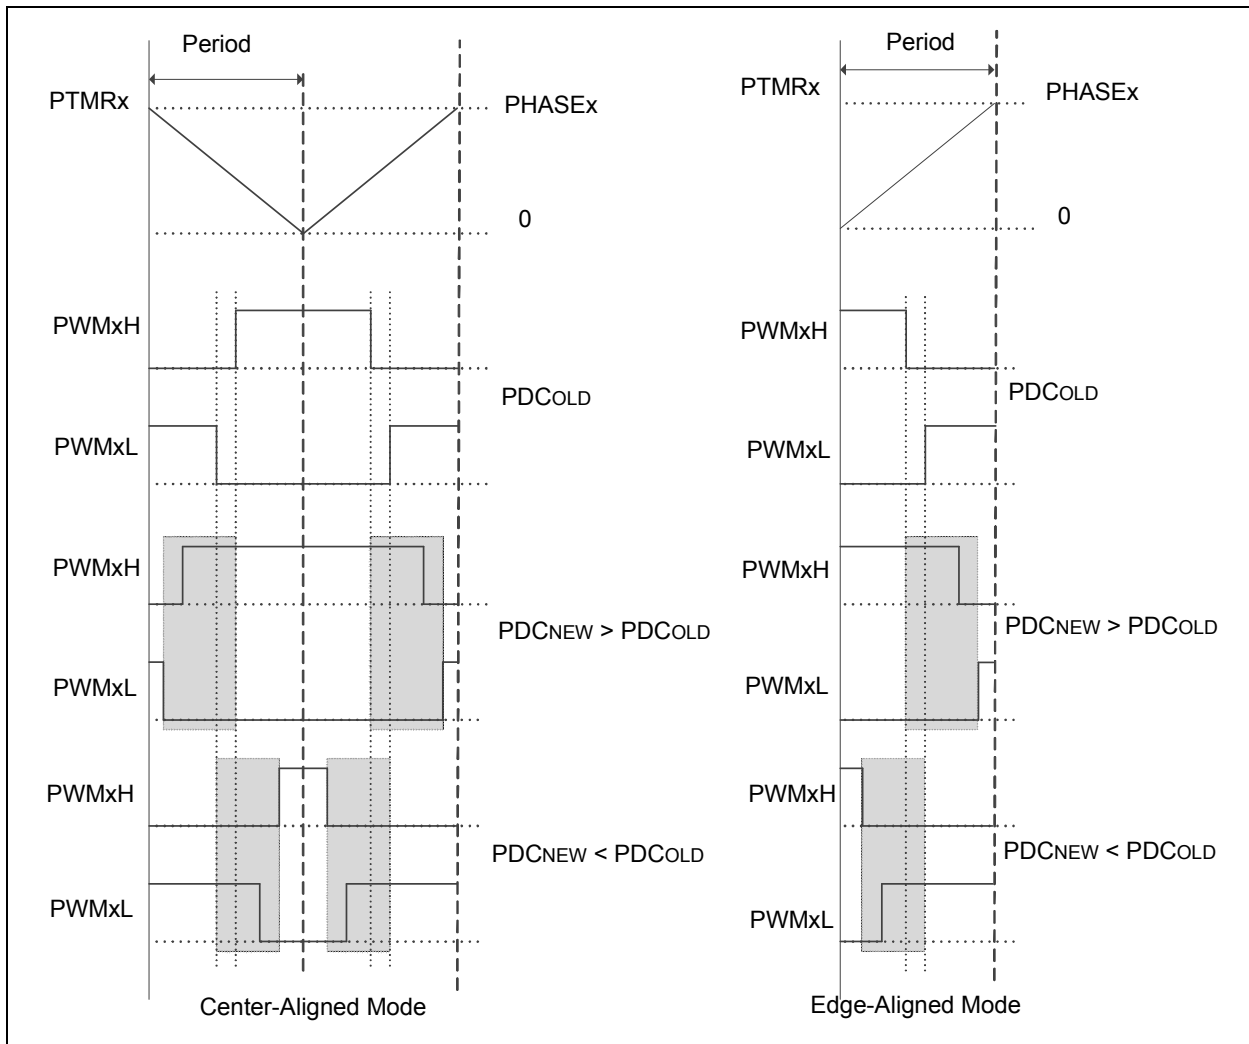
**FIGURE 1: TIMING DIAGRAMS FOR CENTER-ALIGNED AND EDGE-ALIGNED MODES**

The PWMx generator may not assert dead time on the edges of transitions. This has been observed when all of the following conditions are present:

The current duty cycle, PDCOLD, newly calculated duty cycle, PDCNEW, and the point at which the write to the Duty Cycle register occurs within the PWMx time base, will determine if the PWMxH and PWMxL outputs make an immediate transition. PWMxH and PWMxL outputs make an immediate transition if the Duty Cycle register is written with a new value, PDCNEW, at a point of time when the PWMx time base is

counting a value that is in between PDCNEW and PDCOLD. Additionally, writing to the Duty Cycle register close to the instant of time where dead time is being applied may result in reduced dead time, effective on the PWMxH and PWMxL transition edges.

In Figure 1, if the duty cycle write occurred in the shaded box, then PWMxH and PWMxL will make an immediate transition without dead time.

None. However, in most applications, the duty cycle update timing can be controlled using the TRIGx trigger or Special Event Trigger to avoid the above mentioned conditions.

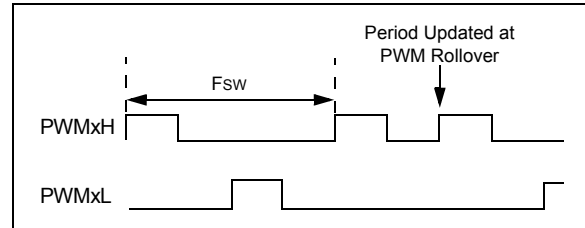
FIGURE 2:

When the PWM module is configured for Push-Pull mode (IOCONx<11:10> = 0b10) with the Enable Immediate Period Update bit enabled (PTCON <10> = 1), a write to the Period register that coincides with the period rollover event may cause the push-pull output logic to produce back-to-back pulses on the PWMx pins (see Figure 2).

Ensure that the update to the PWM Period register occurs away from the PWM rollover event by setting the EIPU bit (PTCON<10> = 1). Use either the PWM Special Event Trigger (SEVTCMP) or the PWM Primary Trigger (TRIGx) to generate a PWM Interrupt Service Routine (ISR) near the start of the PWM cycle. This ISR will ensure that period writes do not occur near the PWM period rollover event.

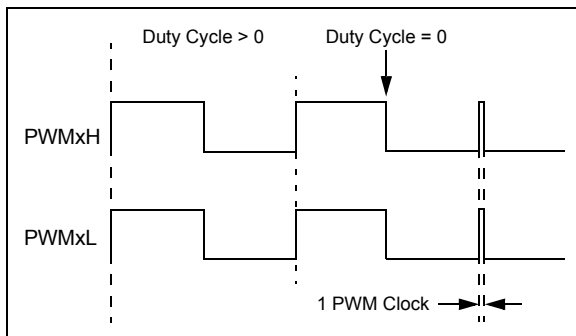
**FIGURE 3: EXAMPLE FOR REDUNDANT OUTPUT MODE**

In the Redundant Output mode (IOCONx<11:10> = 0b01) and Push-Pull Output mode (IOCONx<11:10> = 0b10), with the Immediate Update Enable bit disabled (PWMCONx<0> = 0), when the Duty Cycle register is updated from a non-zero value to zero, a glitch pulse of a width equal to 1 PWM clock will appear at the next PWM period boundary, as shown in Figure 3 (for the Redundant Output mode). The Duty Cycle register refers to the PDCx register if PWMCONx<8> = 0 or the MDC register if PWMCONx<8> = 1.

If the application requires a zero duty cycle output, there are two possible work around methods:

1. Use the PWM override feature to override the PWM output to a low state instead of writing to the Duty Cycle register. In order to switch back to a non-zero duty cycle output, turn off the PWM override. The override-on and override-off events must be timed close to the PWM period boundary if the IOCONx register has been configured with IOCONx<0> = 0 (i.e., output overrides through the OVRDAT<1:0> bits occur on the next CPU clock boundary).

Enable the Immediate Update Enable bit (PWMCONx<0> = 1) while configuring the PWMx module (i.e., before enabling the PWMx module, PTCON<15> = 1). With the Immediate Update enabled, writes to the Duty Cycle register can have an immediate effect on the PWM output. Therefore, the duty cycle write operations must be timed close to the PWM period boundary in order to avoid distortions in the PWM output.
